# Copper Slough at Staley Road at Champaign, IL

**Study Reach.**--The channel reach under consideration is a constructed channel in an urban setting, as shown on the quadrangle map at the top left. The study reach, about 750 ft. long, is located just downstream of the Staley Road bridge and upstream of the confluence with Phinney Branch. Four cross sections (surveyed by Clark-Dietz, Inc. in January 2005) are available for describing the channel geometries in the study reach. The channel alignment, approximate variations in channel width and bank conditions, and locations of cross sections are shown in the aerial photo on the top right. Because of the similarities in cross sectional geometries, cross sectional plots are river stations (RS) 11900, 11800, 11400, and 11300, as plotted above, are selected as representative cross sections.

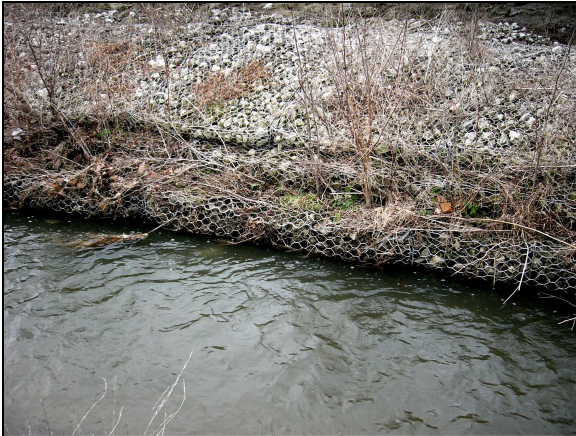
05590060 Copper Slough at Staley Rd at Champaign, IL  
Gabion boxes, west of Staley Rd.

**Description of Channel.**--This channel has concrete sidewalls along the north end of the reach but reverts to a grassy embankment for the downstream portion. The bed material consists of mud, sand, gravel, and small cobbles. The low water control is the channel. Higher stages are controlled downstream of Staley Road by gabion boxes on both banks and a grassed, earthen berm above the gabions. The right-side berm is generally mowed as needed. The bed is filled with gravel, sand, and small cobbles. Banks are wire gabion boxes filled with crushed rocks stacked three tiers high.

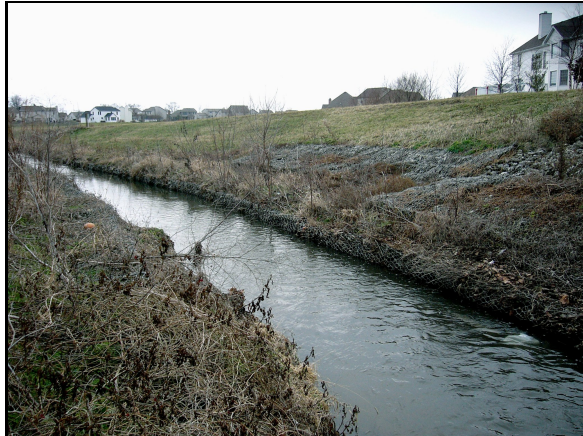
05590060 Copper Slough at Staley Rd at Champaign, IL  
Looking downstream, below Staley Road

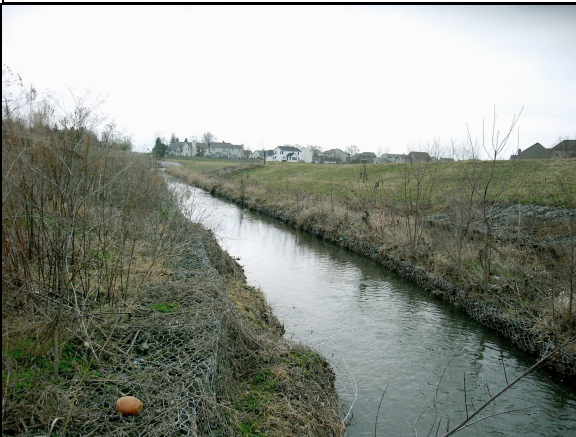
05590060 Copper Slough at Staley Rd at Champaign, IL  
Looking downstream

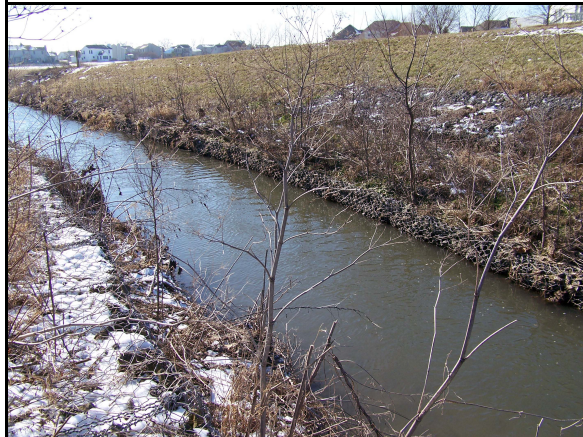
05590060 Copper Slough at Staley Rd at Champaign, IL  
Looking downstream below Staley Road

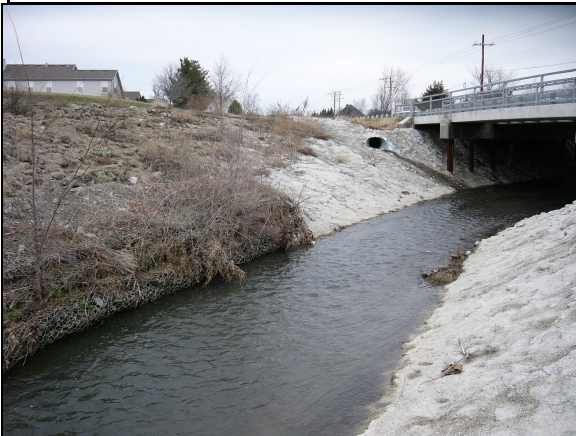
05590060 Copper Slough at Staley Rd at Champaign, IL  
Looking upstream

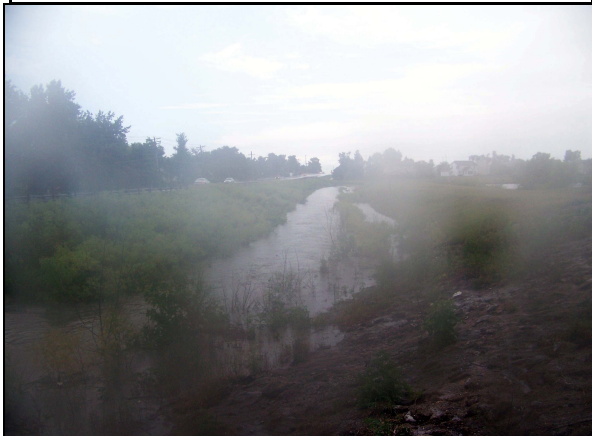
05590060 Copper Slough at Staley Rd at Champaign, IL  
Looking Downstream
